**ATTACHMENT F: RIPARIAN BIRD SURVEY REPORT**

**SAN DIEGO GAS & ELECTRIC COMPANY AND SOUTHERN CALIFORNIA GAS COMPANY  
PIPELINE SAFETY & RELIABILITY PROJECT  
RIPARIAN BIRD SURVEY REPORT**

**September 2015**

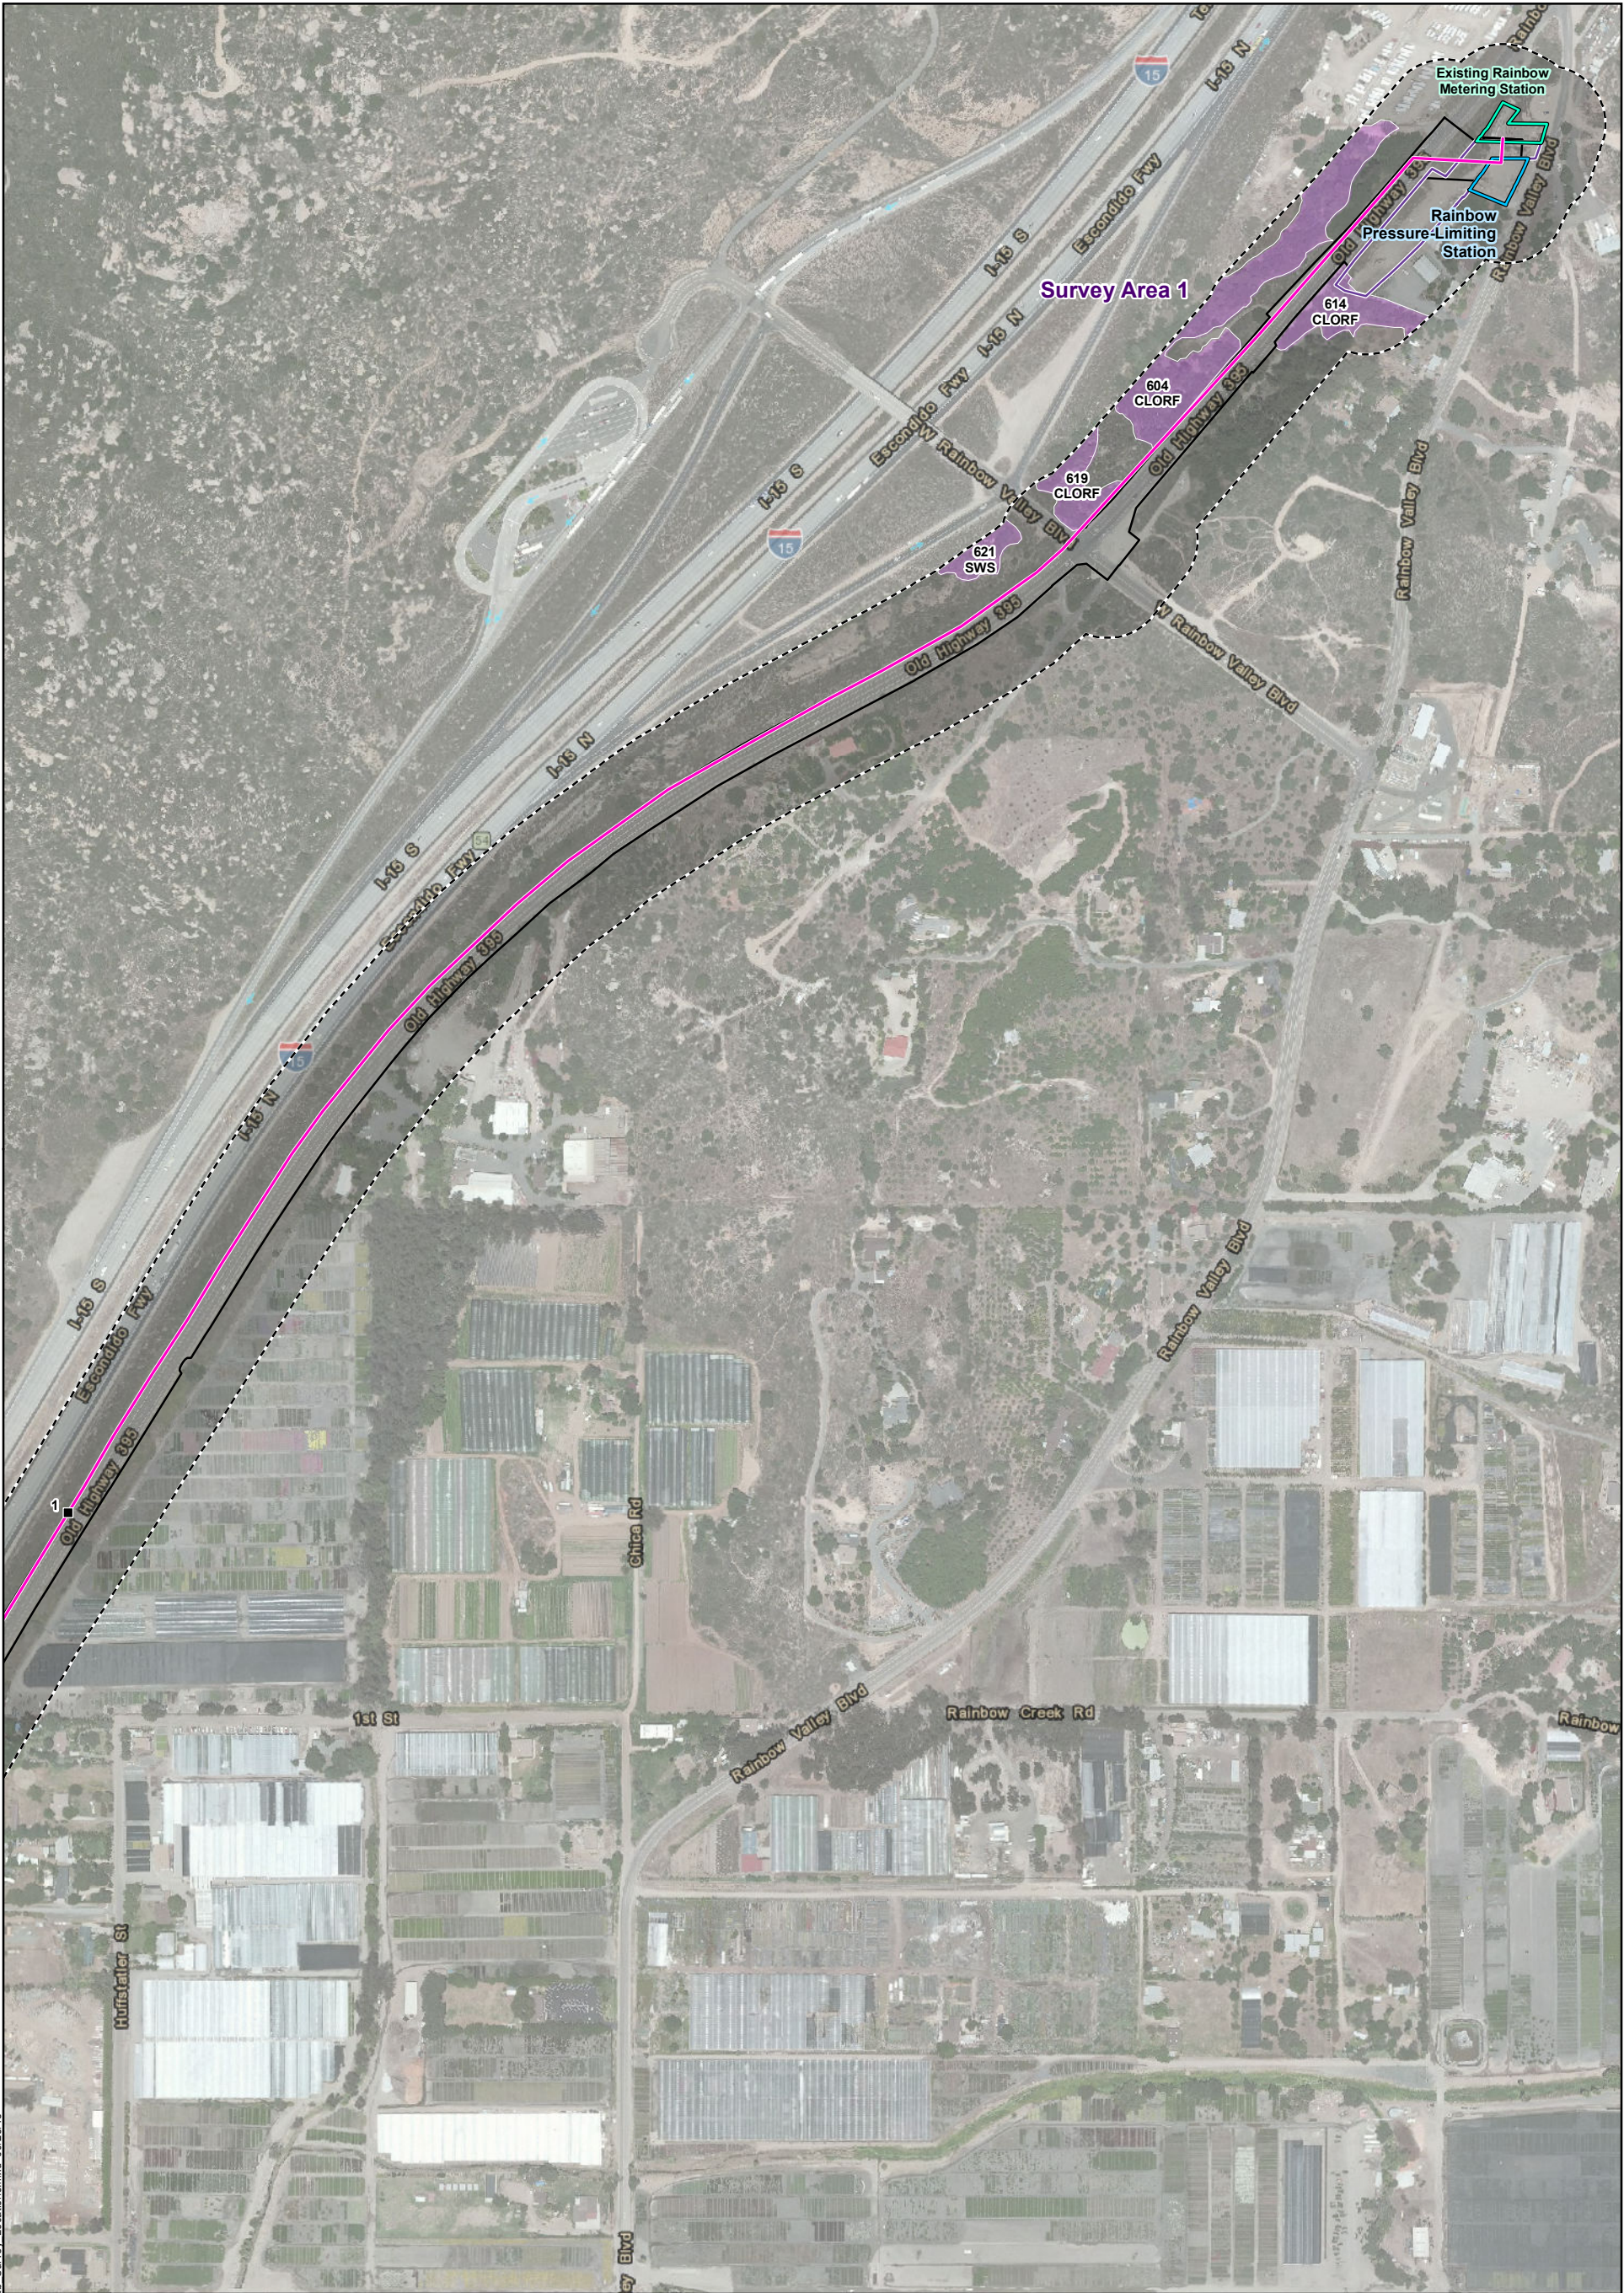
Attachment A: 2015 LBV/SWFL Survey Area and Sightings Map 1 of 20

- Please note survey route not shown due to large map scale, meandering transects were walked within suitable habitat during protocol surveys

CNDDDB occurrences of least Bell's vireo that have been documented immediately adjacent to the riparian bird survey areas are shown on Attachment A: 2015 Least Bell's Vireo/Southwestern Willow Flycatcher Survey Area and Sightings. All CNDDDB occurrences of least Bell's vireo and southwestern willow flycatcher within five miles of the BRSA are shown in Figure A-2: CNDDDB Occurrences for Special-Status Wildlife Species in the Biological Resources Technical Report (Insignia 2015).

The survey areas are shown on Attachment A: 2015 Least Bell's Vireo/Southwestern Willow Flycatcher Survey Area and Sightings. Attachment B: Survey Area Summary Characteristics Table summarizes the geographic locations of the survey areas, the names of the drainages flowing through or associated with the surveys areas, and the vegetation communities observed within the survey areas.
